Unexpected Voids

Lessons Learned: Unexpected Voids

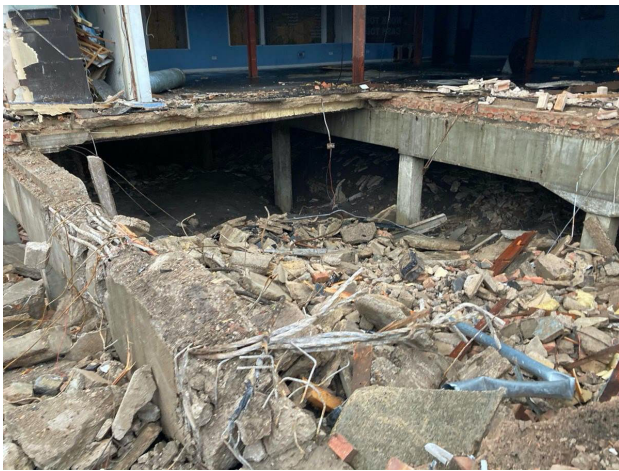
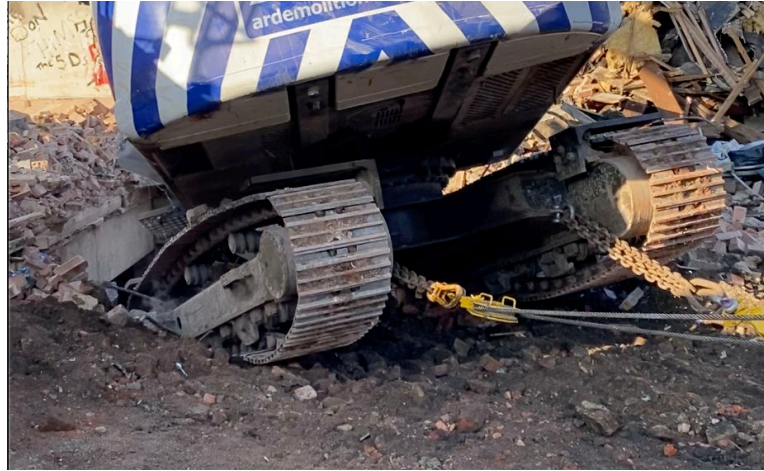
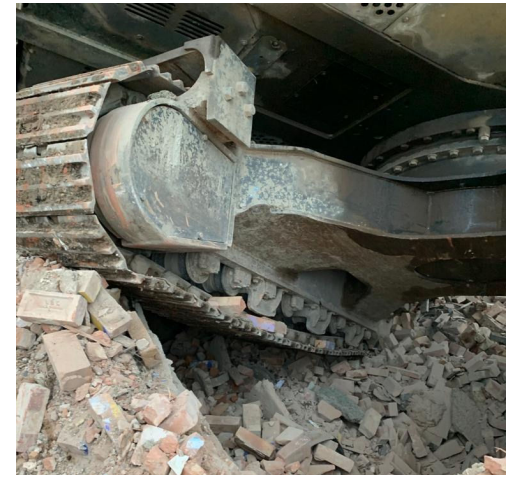
An unfortunate incident occurred involving the collapse of a ground floor slab after a demolition rig tracked above an unknown void. **Thankfully no one was injured**, however the incident serves as a stark reminder of the inherent dangers within demolition works.

A full investigation is ongoing into the incident. Early findings outline that the structure had been constructed on columns with a suspended ground floor slab, creating a **tapered void** measuring at various depths ranging from appx 0.1m to 3m across opposite ends of the structure.

- Whilst visual & physical investigations, surveys and inspections of the structure are a vital control, the use of further tools such as GPR should be used more common place.

- The physical marking out and exclusion around underground hazards are a key final barrier in avoiding collapses and should be adopted at all times.
- Intrusive or physical checks should be undertaken by plant operators to assess the ground prior to tracking over new or changing areas of a structure.
